# A COMPREHENSIVE REVIEW IN ULTRASONIC NON-DESTRUCTIVE TESTING AND EVALUATION FOR CARBON FIBRE REINFORCED PLASTICS STRUCTURES

M. RAMESH KUMAR, AMITABHA DATTA\* AND V. SRINIVASA

Advanced Composites Division, CSIR-National Aerospace Laboratories, Bengaluru 560017, India

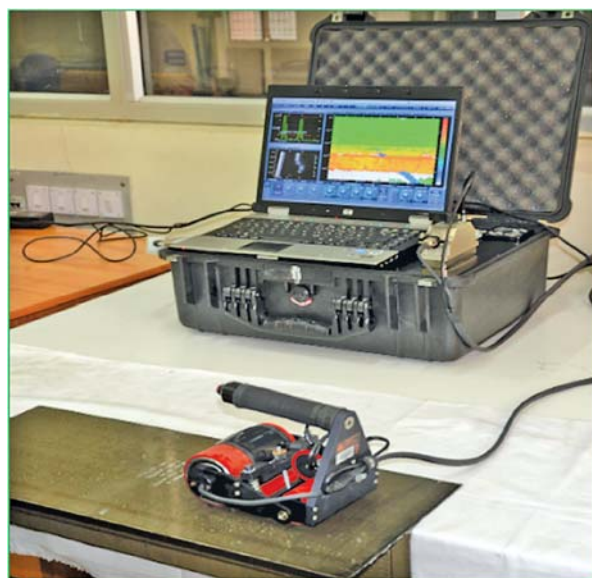
**Fig. 2:** Pulse echo linear Array Roller Probe (Rapid Scan System) deployed at CSIR-NAL

***Pulse Echo Linear Array Roller Probe System:*** The linear array roller probe, Rapid Scan system from Sonatech<sup>34</sup> illustrated in Fig. 2 is equipped with advanced

features that allow for simultaneous live A, B, and C-scans, facilitating comprehensive inspections across large areas. This capability is particularly beneficial for identifying defects or anomalies in carbon composite laminates and other structural materials. Post-inspection data processing is carried out using full waveform capture, ensuring detailed analysis and accurate defect characterization. The pulsar type utilized in the system is a negative square wave, delivering a consistent amplitude of 70 V. This waveform is optimized for generating precise and reliable ultrasonic signals. The pulse width can be adjusted between 25 ns to 250 ns, offering flexibility to adapt to various testing requirements and material types. With 32 active channels as a standard configuration, the system provides a robust foundation for inspections. Additionally, it can be expanded to accommodate up to 128 channels, allowing for increased versatility and

coverage. The system's wide bandwidth, ranging from 1 MHz to 22 MHz, ensures high-resolution imaging and detection capabilities. The receiver gain is set at 80 dB, enhancing the system's sensitivity and enabling the detection of subtle defects or discontinuities. Multiple centre frequencies are available, including 2, 5, and 10 MHz, catering to different inspection needs and material thicknesses. Furthermore, the system features an element pitch of 0.8 mm, ensuring precise spatial resolution. The active array width is designed to cover 50 mm, striking a balance between coverage and resolution for efficient inspections.

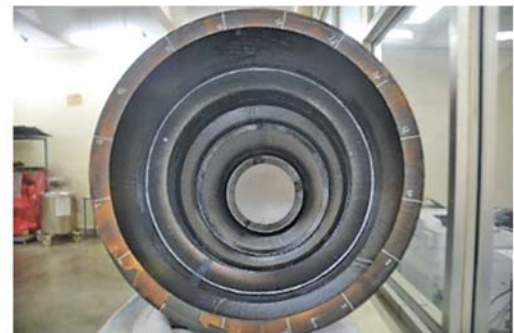
**Fig. 13:** (a) CAD model of shell structure comprised of eight different thickness regions (A to H) (b) Pictorial representation of the structure (c) Manually inspected A- Scan map

The primary drawback of the existing C-Scan inspection system lies in its inability to thoroughly inspect the entire surface of a fully circular structure or shell structure as shown in Fig. 13. The system restricts the inspection to only certain areas of the section, leaving other regions unexamined. As a result, potential defects or imperfections outside the cone's coverage may go unnoticed, leading to compromised product quality and safety concerns. The process of qualifying such a structure after production took a total of 80 man-hours. This qualification process likely involved rigorous testing, inspection, and quality assurance measures to ensure that the structure met the required standards and specifications. Now, with the system that we are proposing, there will be a substantial improvement in the qualification process. The man-hours required for qualification are anticipated to reduce by a factor of three. This means that the proposed system is expected to be much more efficient and streamlined in its testing and inspection procedures. In other words, the qualification of the new system is estimated to take only one-third of the time it took to qualify the existing structure. This reduction in man-hours signifies a significant improvement in productivity, allowing
